**California Department of Fish and Game**  
**Petaluma River Watershed**  
**Stream Habitat Assessment Reports**  
**Lynch Creek**  
*Surveyed 2007*

## **STREAM INVENTORY REPORT**

### **Lynch Creek**

*Surveyed Summer 2007*

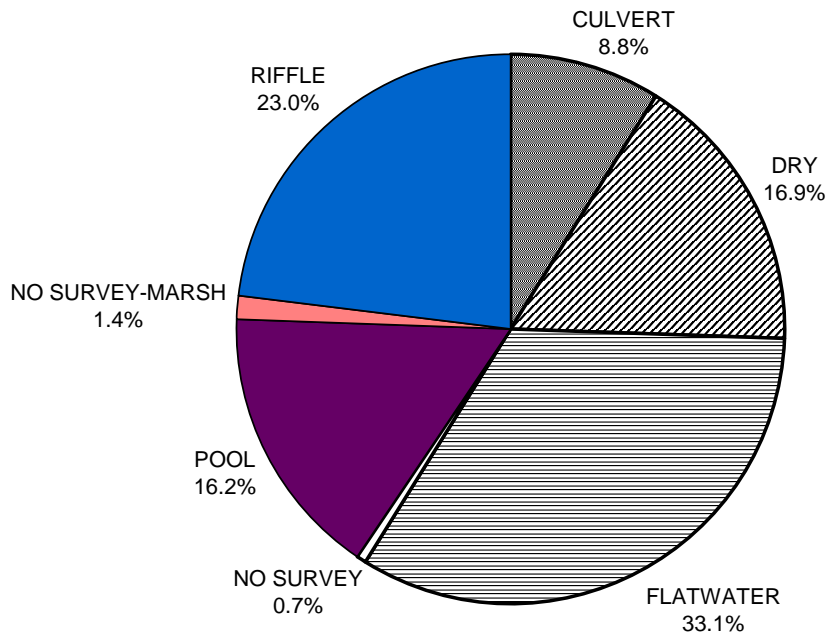
GRAPH 1

### LYNCH CREEK 2007 HABITAT TYPES BY PERCENT OCCURRENCE

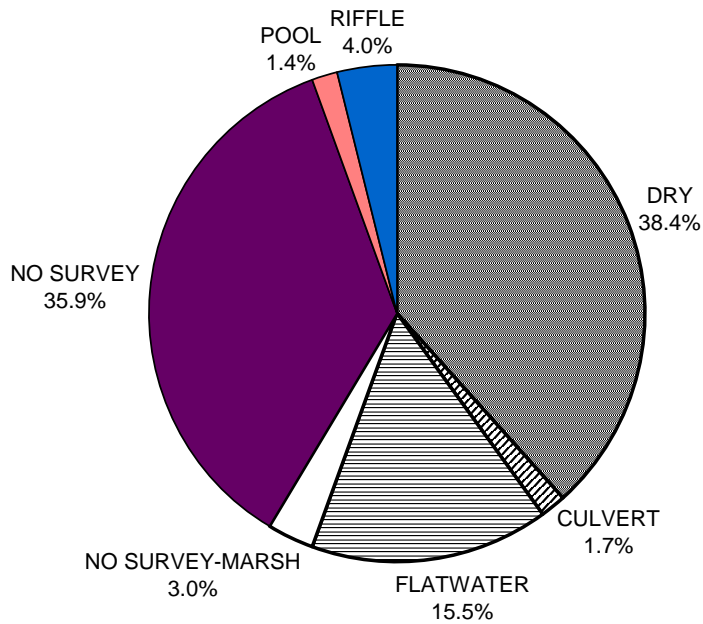
GRAPH 2

### LYNCH CREEK 2007 HABITAT TYPES BY PERCENT TOTAL LENGTH

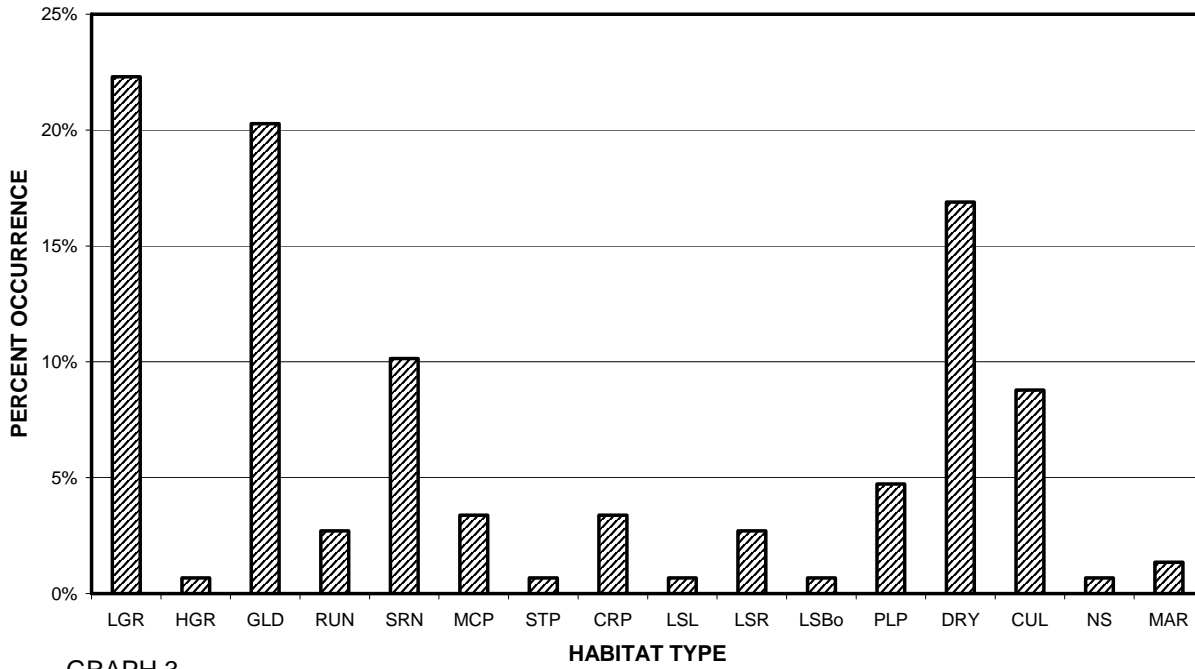
GRAPH 3

### LYNCH CREEK 2007 HABITAT TYPES BY PERCENT OCCURRENCE

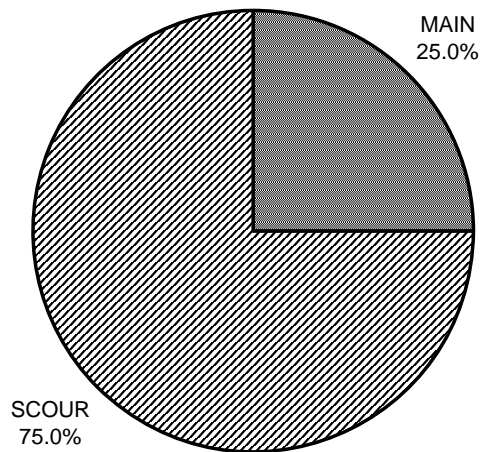
GRAPH 4

### LYNCH CREEK 2007 POOL TYPES BY PERCENT OCCURRENCE

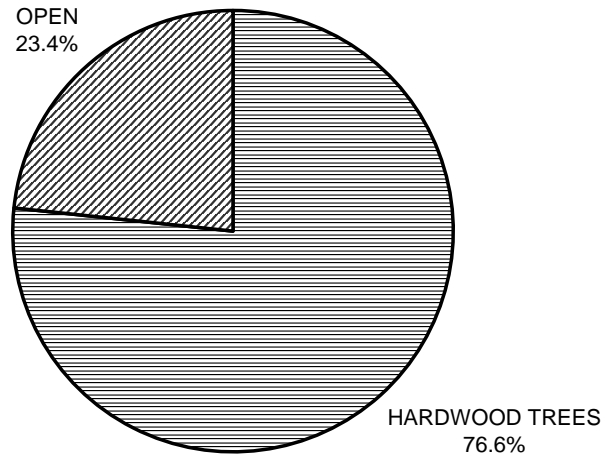
GRAPH 9

**LYNCH CREEK 2007  
MEAN PERCENT CANOPY**

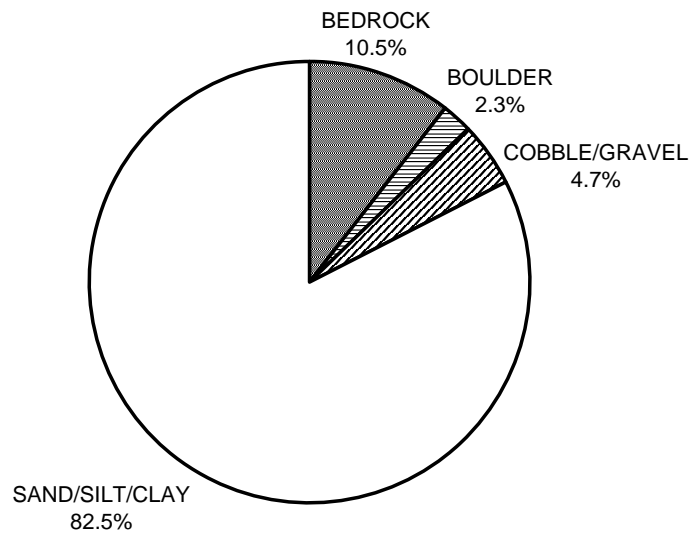
GRAPH 10

**LYNCH CREEK 2007  
DOMINANT BANK COMPOSITION IN SURVEY REACH**

For the stream reach surveyed, the mean percent right bank vegetated was 52%. The mean percent left bank vegetated was also 52%. The dominant elements composing the structure of the stream banks consisted of 83% sand/silt/clay, 10% bedrock, 5% cobble/gravel, and 2% boulder (Graph 10). Brush was the dominant vegetation type observed in 41% of the units surveyed. Additionally, 38% of the units surveyed had hardwood trees as the dominant vegetation type, and 14% had grass as the dominant vegetation (Graph 11).

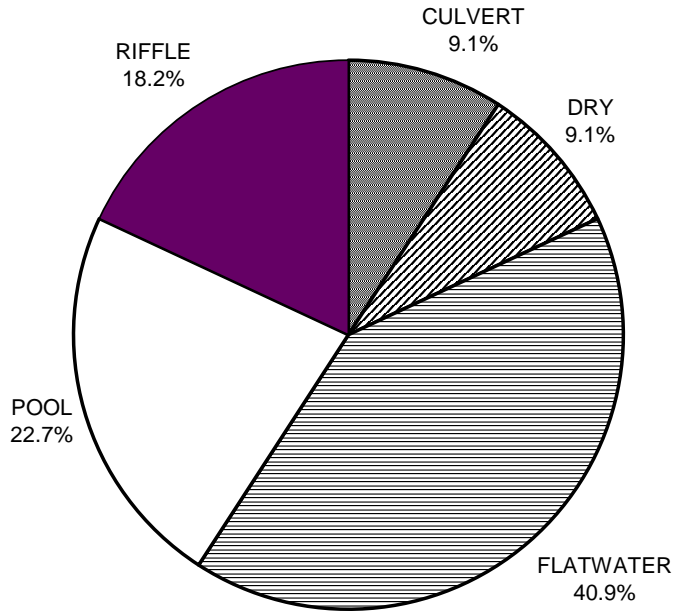
GRAPH 1

**Unnamed Tributary #1 to Lynch Creek 2007  
HABITAT TYPES BY PERCENT OCCURRENCE**

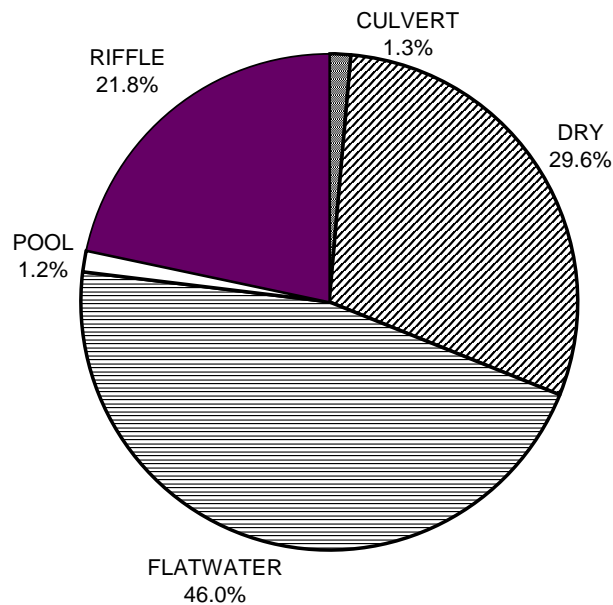
GRAPH 2

**Unnamed Tributary #1 to Lynch Creek 2007  
HABITAT TYPES BY PERCENT TOTAL LENGTH**

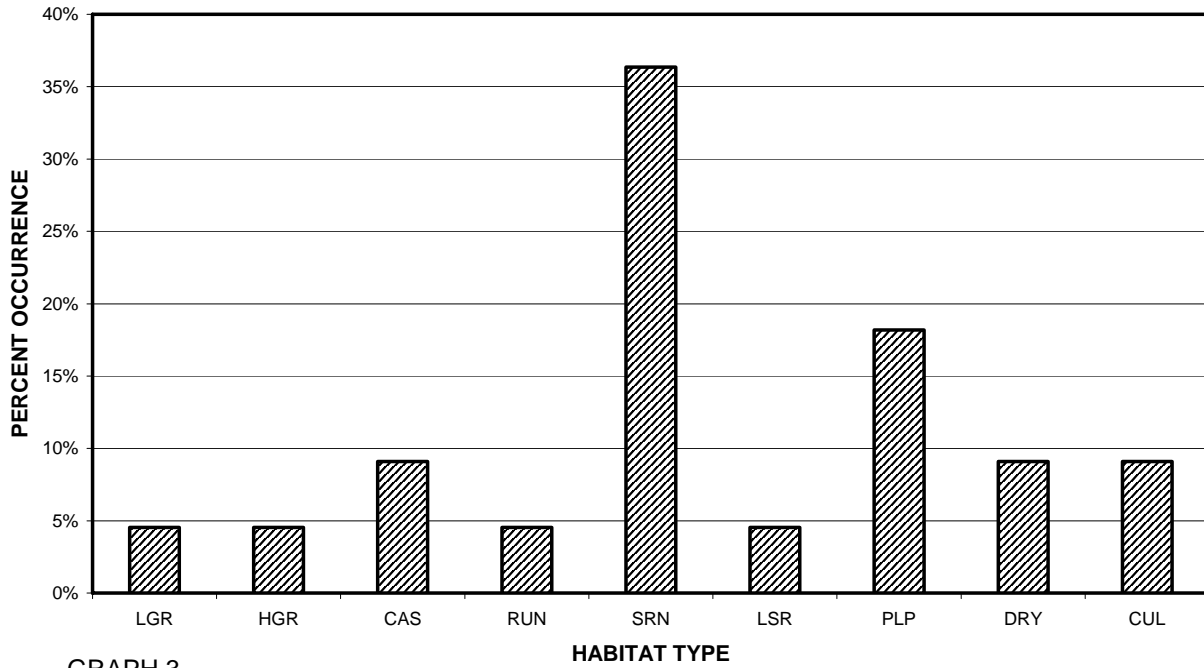
GRAPH 3

**Unnamed Tributary #1 to Lynch Creek 2007  
HABITAT TYPES BY PERCENT OCCURRENCE**

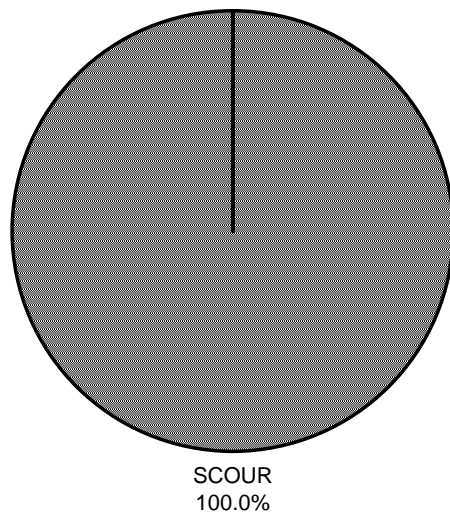
GRAPH 4

**Unnamed Tributary #1 to Lynch Creek 2007  
POOL TYPES BY PERCENT OCCURRENCE**

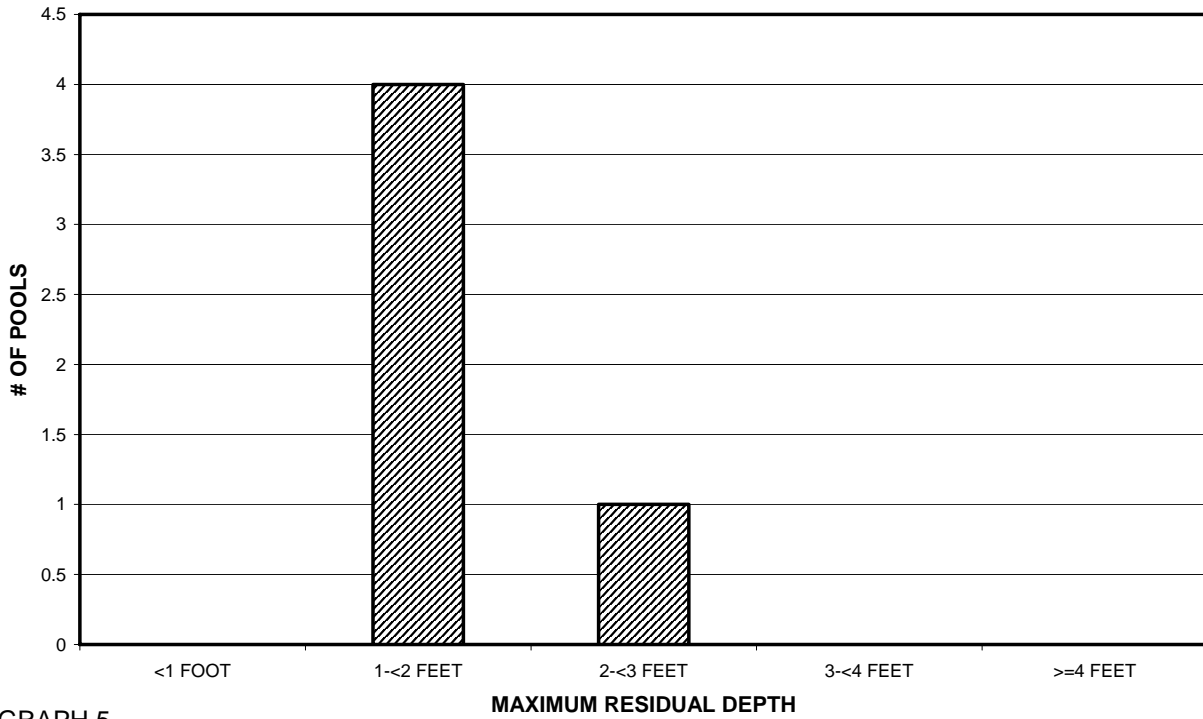
GRAPH 5

**Unnamed Tributary #1 to Lynch Creek 2007  
MAXIMUM DEPTH IN POOLS**

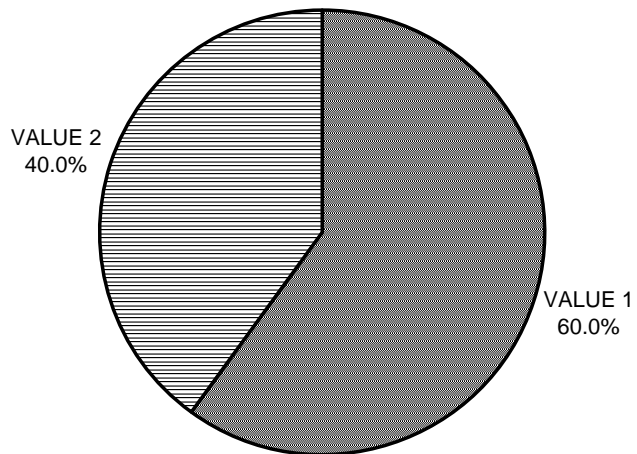
GRAPH 6

**Unnamed Tributary #1 to Lynch Creek 2007  
PERCENT EMBEDDEDNESS**

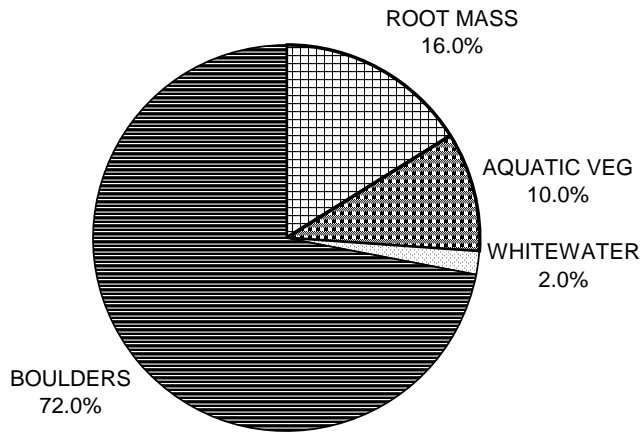
GRAPH 7

### Unnamed Tributary #1 to Lynch Creek 2007 MEAN PERCENT COVER TYPES IN POOLS

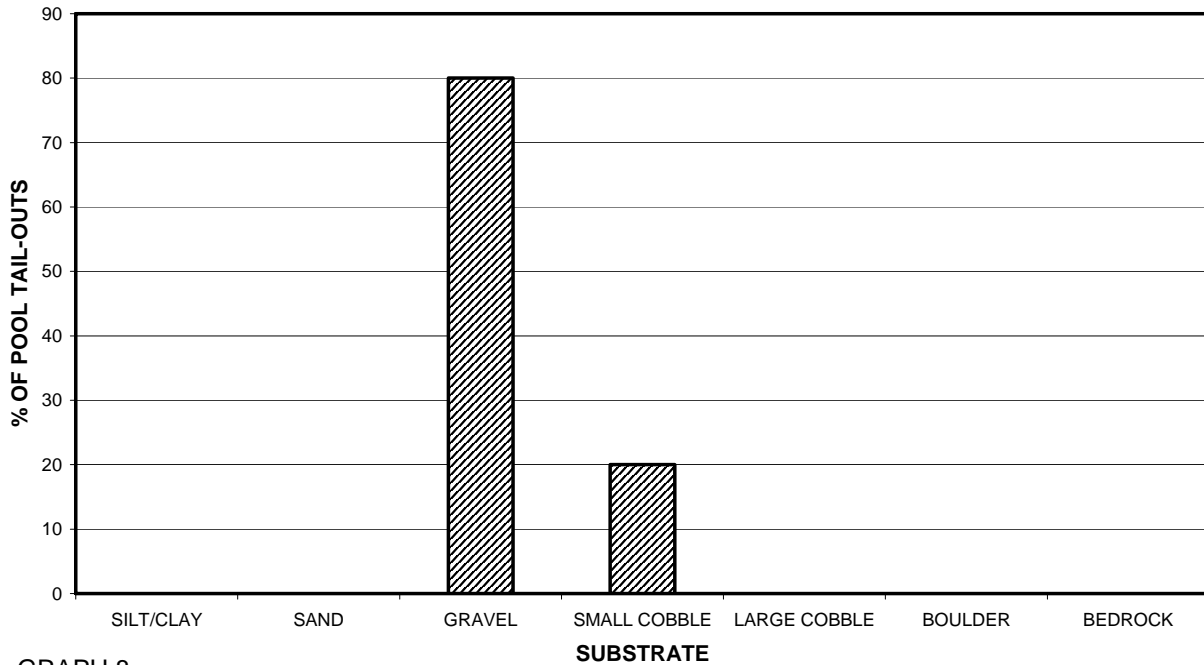
GRAPH 8

### Unnamed Tributary #1 to Lynch Creek 2007 SUBSTRATE COMPOSITION IN POOL TAIL-OUTS

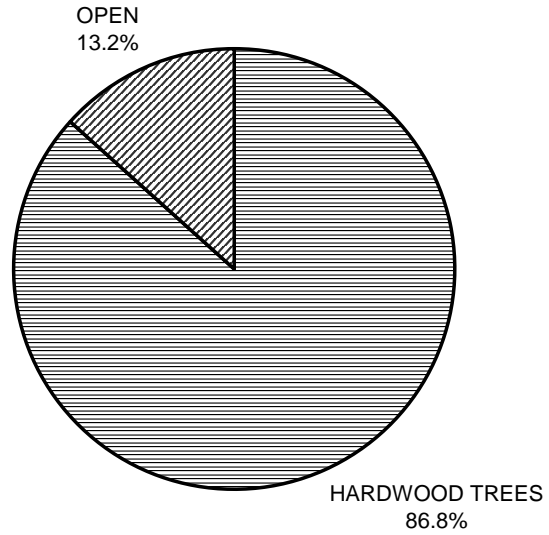
GRAPH 9

**Unnamed Tributary #1 to Lynch Creek 2007  
MEAN PERCENT CANOPY**

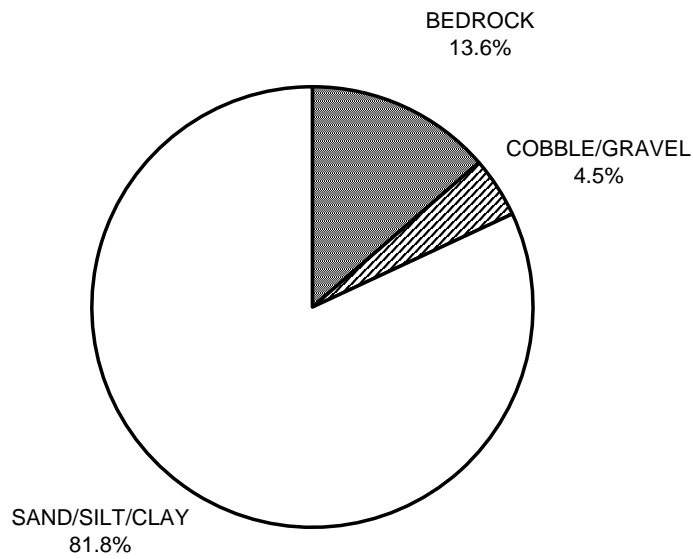
GRAPH 10

**Unnamed Tributary #1 to Lynch Creek 2007  
DOMINANT BANK COMPOSITION IN SURVEY REACH**

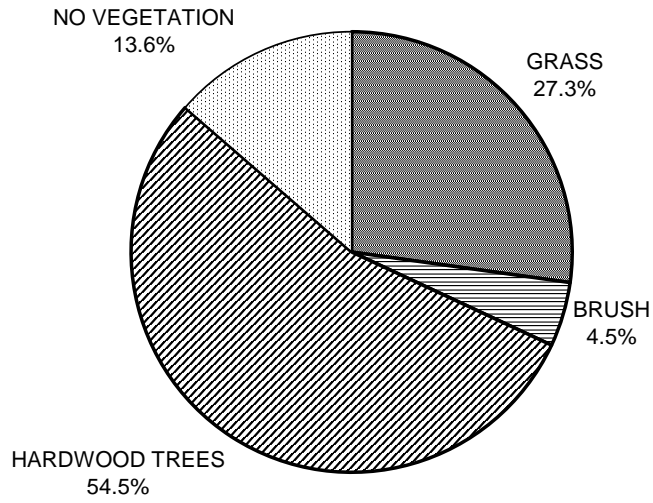
GRAPH 11

**Unnamed Tributary #1 to Lynch Creek 2007  
DOMINANT BANK VEGETATION IN SURVEY REACH**

The percentage of right and left bank covered with vegetation was 26% for both banks, respectively. In areas of stream bank erosion, or where bank vegetation is not at acceptable levels, the planting of endemic species of coniferous and hardwood trees, in conjunction with bank stabilization is recommended.
